STRUCTURES TEST REPORT

ST10088-001-02

LOAD TESTING OF ULTIBRAC TIMBER FRAMING CONNECTORS

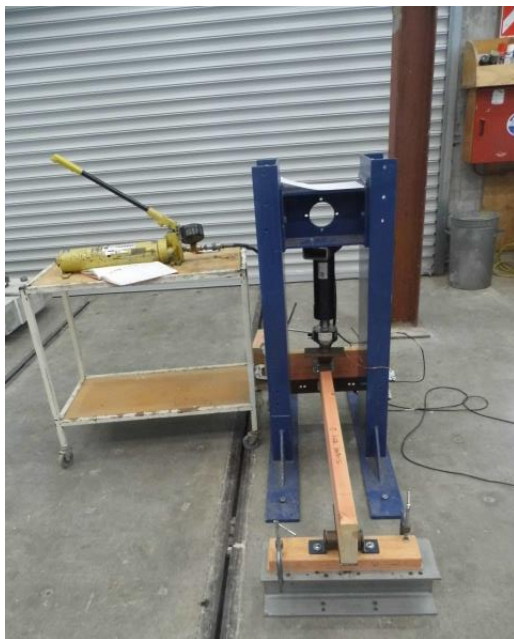
Photograph 2. Test set up for Shear 1 configuration

The specimens were set up for testing on the laboratory floor. See Photograph 2.

Shear 1 configuration (Out-of-plane direction): The short leg of the “T” was clamped to steel supports bolted to the floor. The far end of the long leg was supported on a pivot to prevent restraint due to the change of angle as the joint displaced (see Photograph 3).

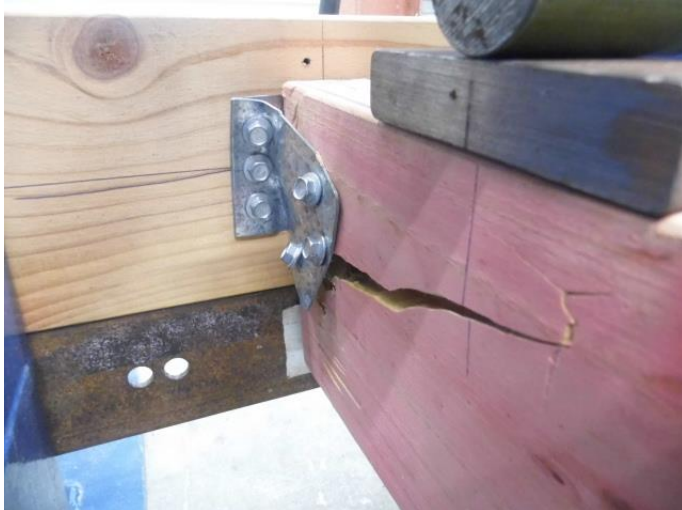
Photograph 6. Failure by end splitting

Specimens failed either by timber fracture (either end splitting, or under the load application point), excessive distortion of the joint and bracket, or by screw withdrawal.

- Photograph 6 shows a typical failure by timber splitting from the end of the long leg. These failures occurred under Shear 1 loading
- Photograph 7 shows a typical failure by timber fracture. These were under Shear 2 loading.
- Photograph 8 shows a typical failure by distortion of the bracket coupled with screw withdrawal. These occurred under Shear 1 loading.
- Photograph 9 shows a typical failure by bracket distortion under Shear 2 loading.
